Memorandum

Re: Wynn Resorts
Water Damage Loss
7th Floor Apartment
817 5th Avenue, New York, NY

Date:	March 16, 2005
Report:	Two
Insured:	Wynn Resorts. LLC
Claim No:	Various
Policy No:	Various
York File No:	SLA-0151A9
Loss Location:	817 5 th Ave., New York, NY
Policy Period:	6/22/2004 - 2005
Type of Claim:	Water Damage
Date of Claim:	12/29/04

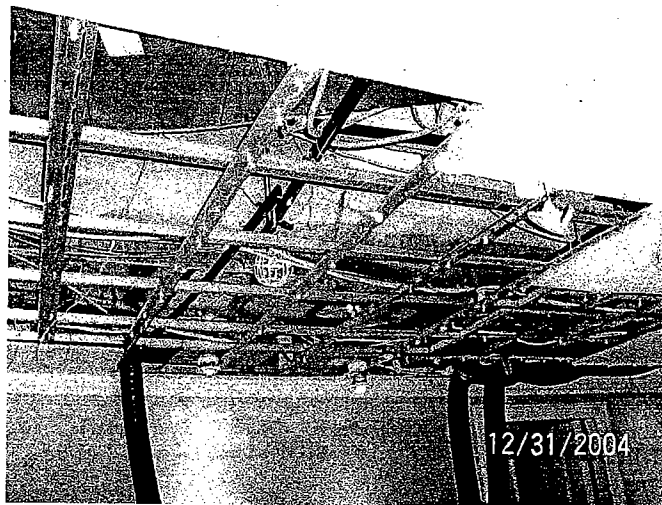
This room has the most serious damage.

MAIN HALLWAY CEILING WITH DRYWALL REMOVED

Replace all of the sheetrock ceiling and insulation. The two-piece crown molding will need to be removed to accomplish this.

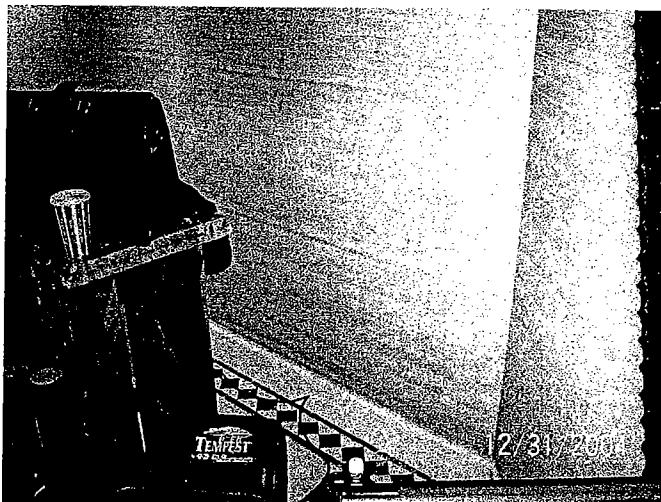
The walls are covered with a padded fabric that was wet and is wrinkling near the baseboard molding. The designer and the contractor who installed the fabric say that it cannot be removed, or stretched in place without causing more damage to the fabric. If the fabric must be repaired, and I believed that it will, then all of the material in the hallway will have to come out. I am told by Tishman construction, that this is an imported German material that is no longer available.

MAIN HALLWAY WALLS WITH FABRIC IN PLACE

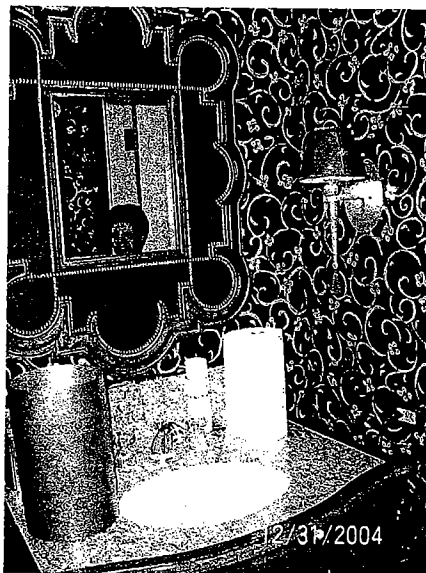
This room was located next to the small closet where most of the water entered the apartment. The wall fabric was still wet when I examined it, and the ceiling and insulation were still in place but obviously damaged to the point that it had to be replaced. Your consultant from Hillman Environmental recommended that the ceiling and the fabric walls be removed to allow for the property drying of this room.

POWDER ROOM WALL FABRIC IN THE AREA WHERE THE WATER ENTERED THE ROOM

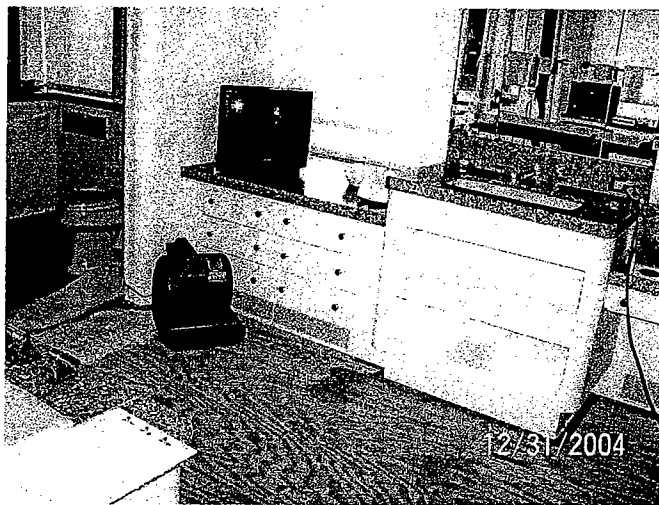
Only the carpeting in these rooms was damaged, and it had already been removed and thrown out by the time I arrived.

BATH ROOM WITH CARPETING REMOVED

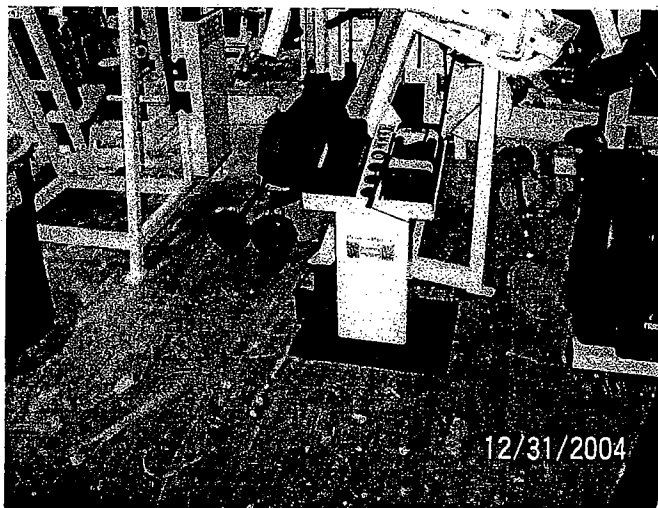
EXERCISE ROOM WITH CARPETING REMOVED

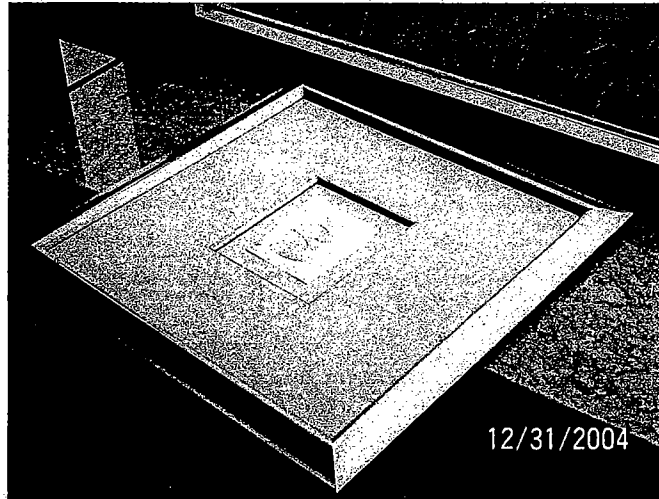
There was very little content damaged by the loss. The housekeeper showed my two paintings that had come in contact with water. The damage appears minor to me. The actual painting was not damaged, but the mat and the back of the frame was. I believe that these items can be re-

SMALL RELIEF ETCHING WITH STAIN ON LEFT SIDE OF MAT

framed. I do not think an art conservation expert is needed to evaluate the condition of these two paintings.

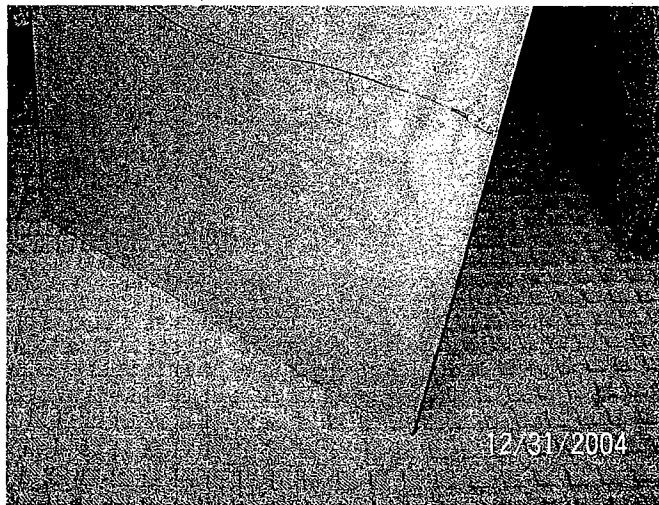
LARGER PRINT WITH WATER STAIN ON THE BACK
